POST RENOVATION FRONT FACADE

POST RENOVATION SITE / FLOOR PLAN

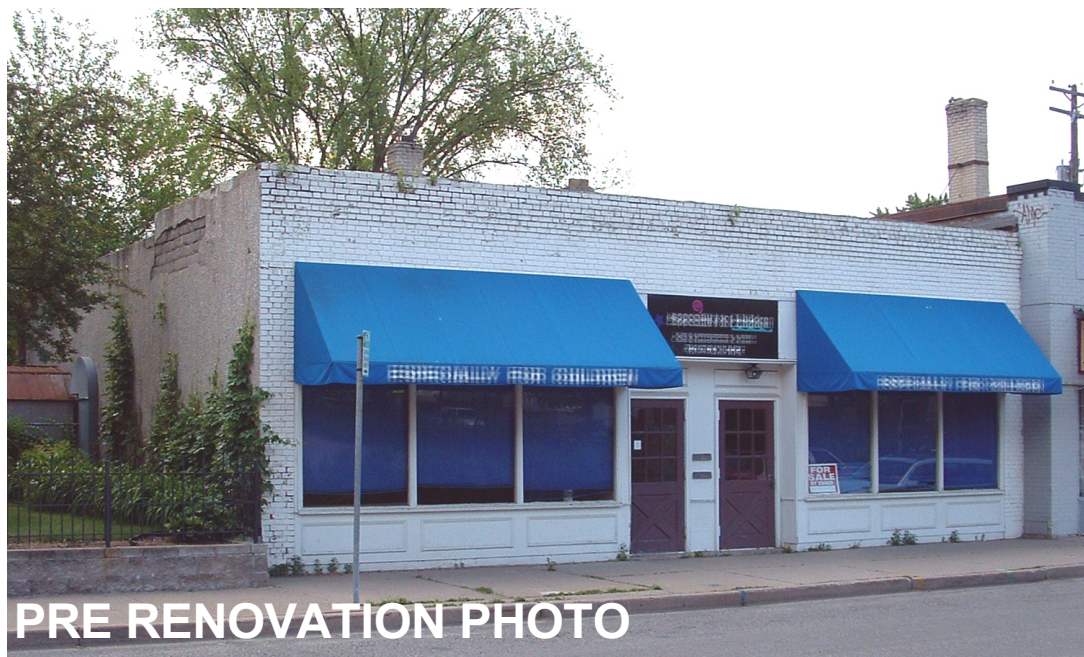
PRE RENOVATION PHOTO

- TYPICAL FACADE MATERIALS**
- REMOVE PAINT AND RESTORE EXISTING BRICK
  - PAINTED STEEL COLUMNS AND BEAM
  - STUCCO INFILL
  - ALUMINUM CLAD WOOD DOORS AND WINDOWS
  - CORRUGATED METAL SIGNAGE AND CANOPIES

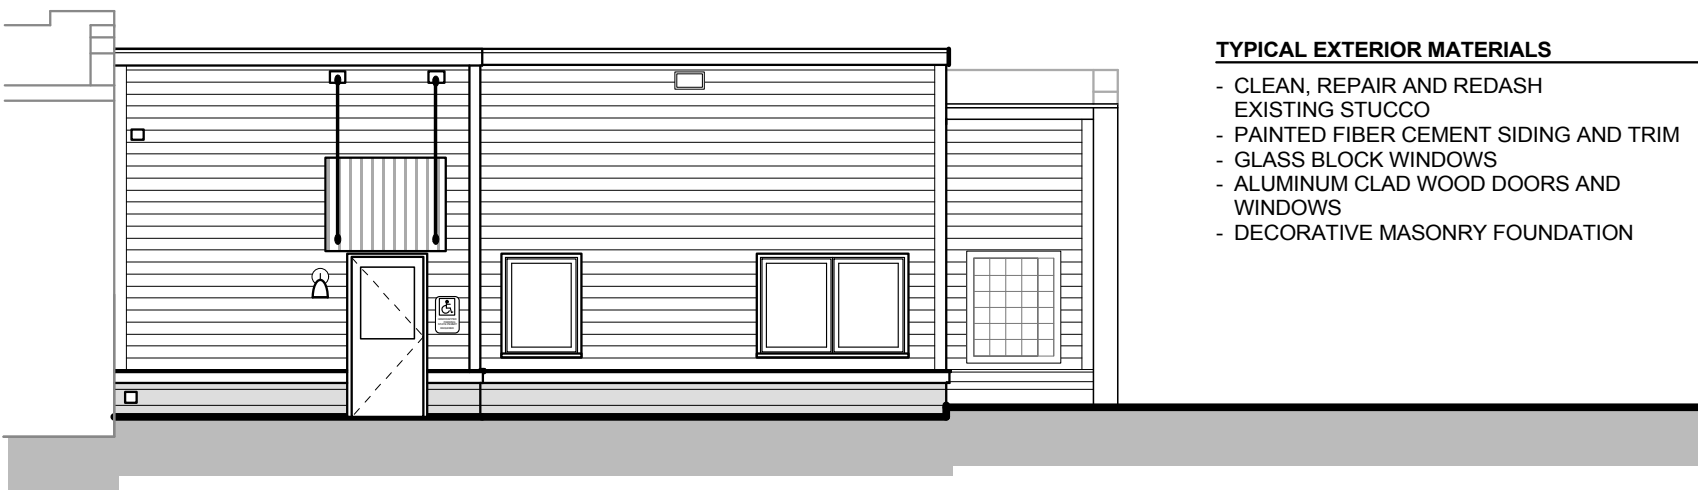
- TYPICAL EXTERIOR MATERIALS**
- CLEAN, REPAIR AND REDASH EXISTING STUCCO
  - PAINTED FIBER CEMENT SIDING AND TRIM
  - GLASS BLOCK WINDOWS
  - ALUMINUM CLAD WOOD DOORS AND WINDOWS
  - DECORATIVE MASONRY FOUNDATION

POST RENOVATION REAR ELEVATION

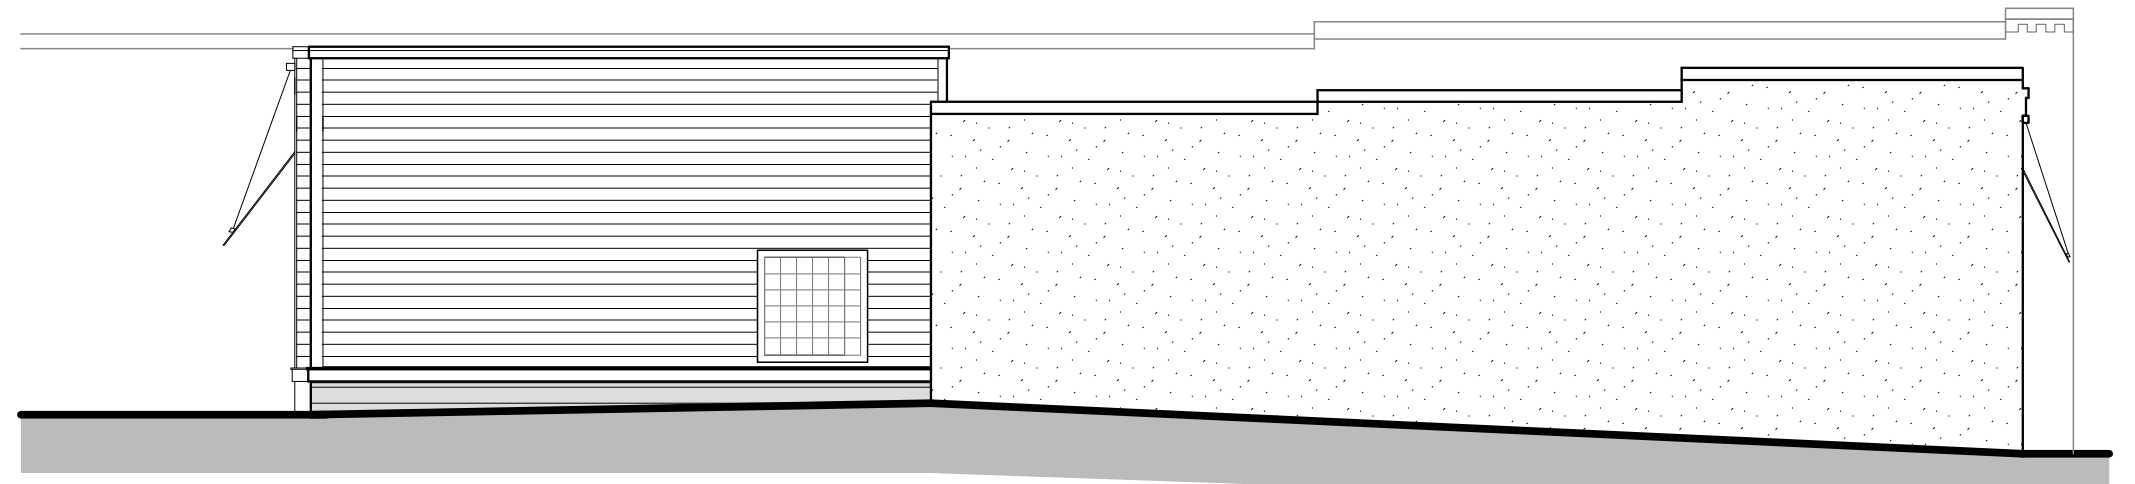
POST RENOVATION SIDE ELEVATION

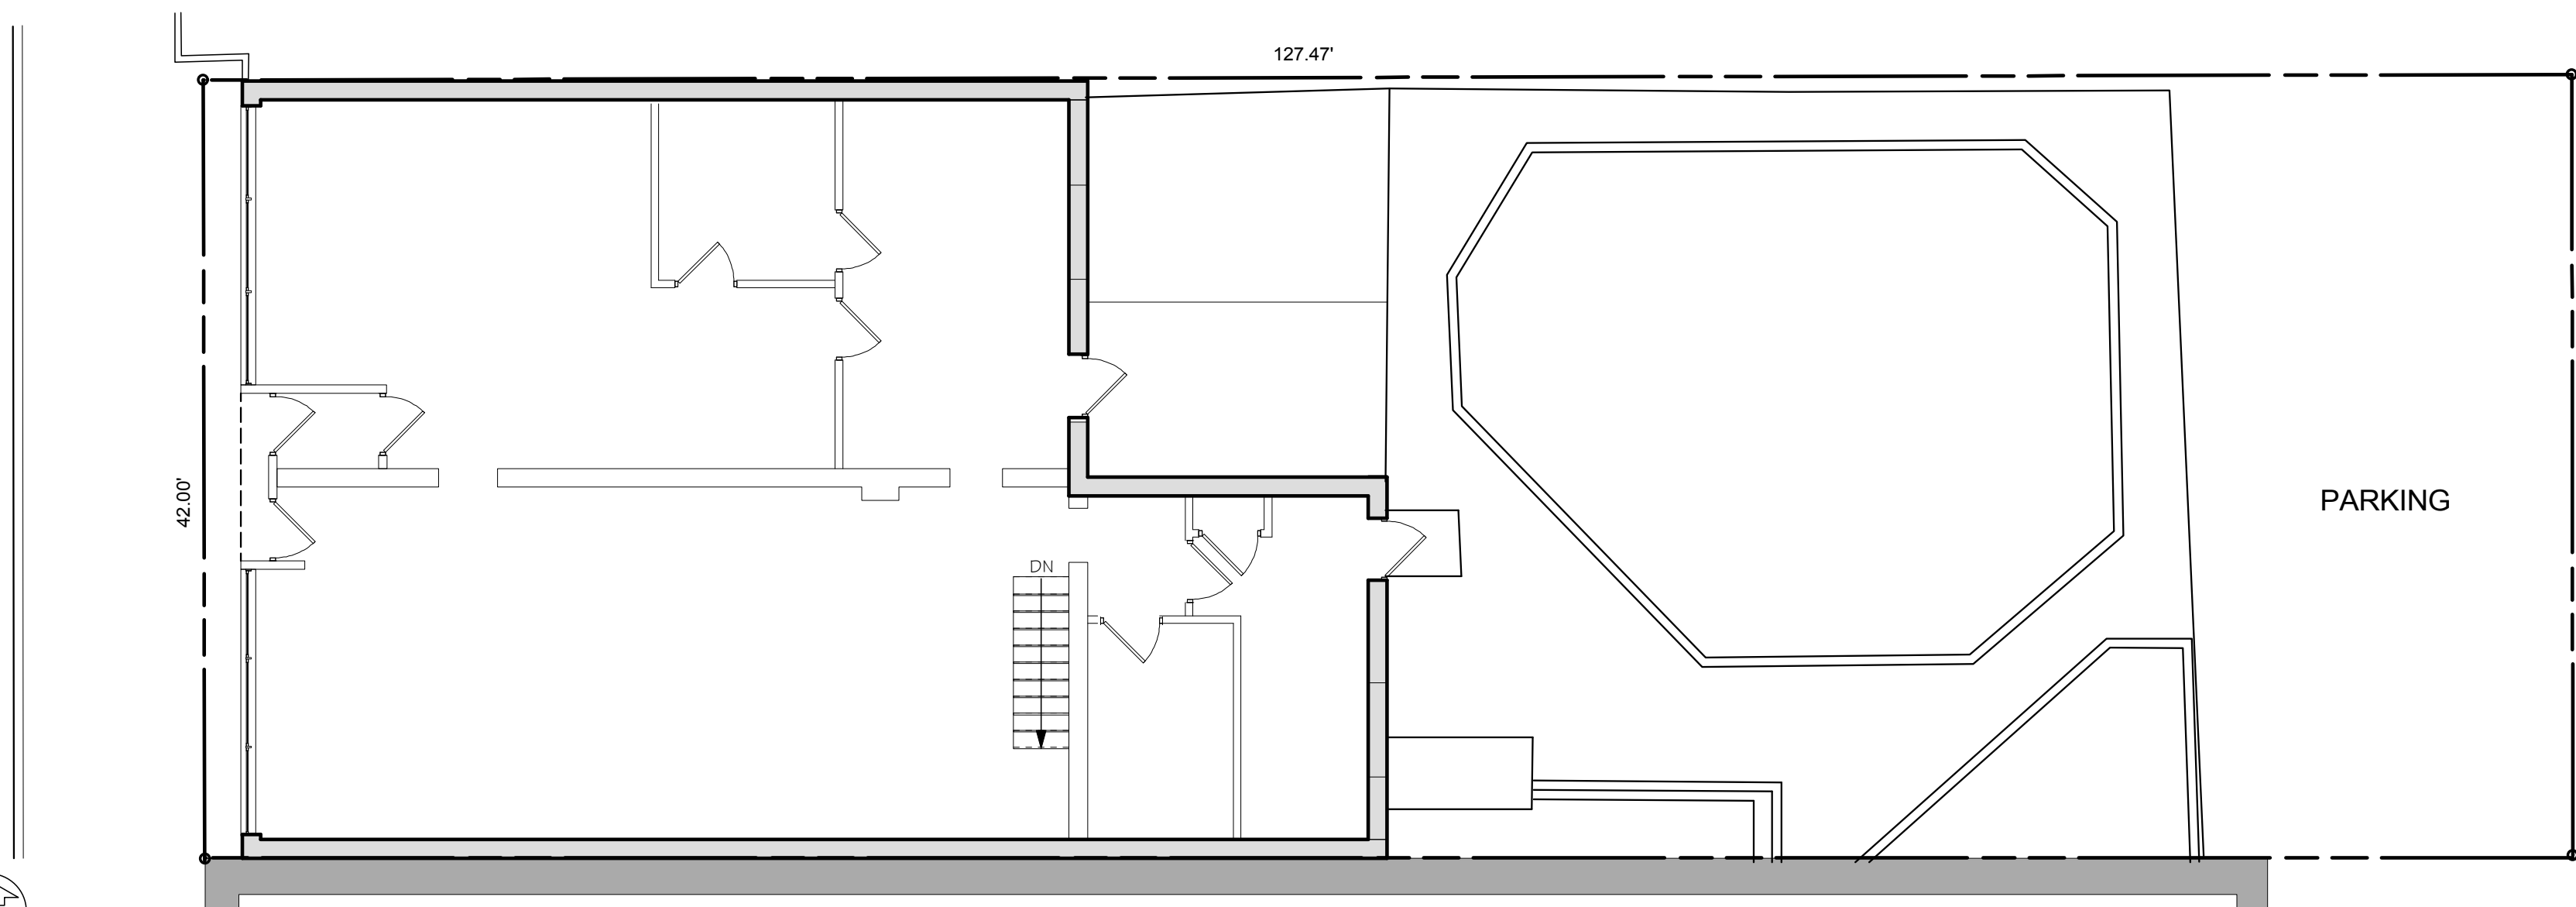
PRE RENOVATION SITE / FLOOR PLAN
